**Flood Control Project Maintenance
Levee Inspections**

Maintenance Issue Types Only, Levee Inspection Report By Mile - Spring 2016

Reclamation District No. 0817 Carlin

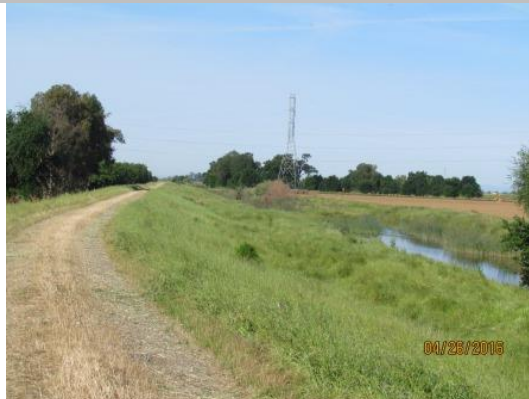
Photo 1 of 1 : SP_2016_RD0817_12_26_20160427_00019.jpg

LM Start	0.01	Rating **	M	Issue No.	26
LM End	3.05	Issue Type +	Ma	Location *	WS
Category	Earthen Levee			GPS Latitude/Longitude	
				Start	End
Item	Vegetation			38.984834 °	39.013119 °
				-121.506088 °	-121.465215 °
DWR ID	DWR_RD0817_01_s_2016_26				
Comment Code					
V1 : Control annual grass and weeds on the levee slopes and easements.					
Inspector Comment

View of vegetation on waterside slope, looking downstream.

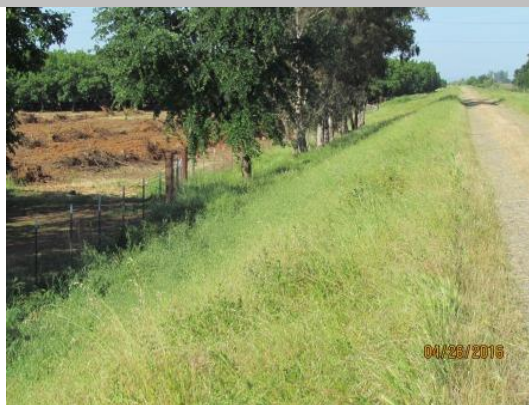
Photo 1 of 1 : SP_2016_RD0817_12_27_20160427_00020.jpg

LM Start	0.01	Rating **	M	Issue No.	27
LM End	3.05	Issue Type +	Ma	Location *	LS
Category	Earthen Levee			GPS Latitude/Longitude	
				Start	End
Item	Vegetation			38.984834 °	39.013119 °
				-121.506088 °	-121.465215 °
DWR ID	DWR_RD0817_01_s_2016_27				
Comment Code					
V1 : Control annual grass and weeds on the levee slopes and easements.					
Inspector Comment

View of typical vegetation on the landside, looking downstream.

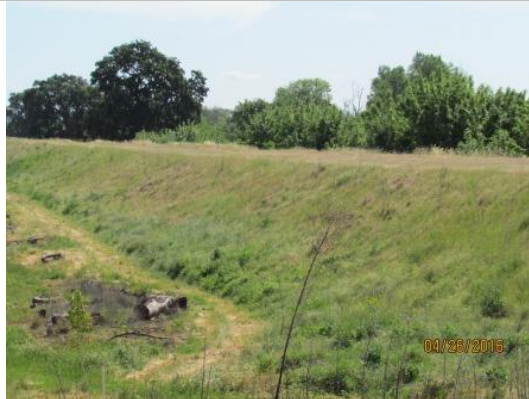
Photo 1 of 1 : SP_2016_RD0817_13_15_20160427_00018.jpg

LM Start	0.01	Rating **	M	Issue No.	15
LM End	3.83	Issue Type +	Ma	Location *	LS
Category	Earthen Levee			GPS Latitude/Longitude	
				Start	End
Item	Vegetation			38.984582 °	38.993173 °
				-121.506061 °	-121.437835 °
DWR ID	DWR_RD0817_02_s _ 2016_15				
Comment Code					
V1 : Control annual grass and weeds on the levee slopes and easements.					
Inspector Comment

View of typical vegetation on the waterside slope looking upstream.

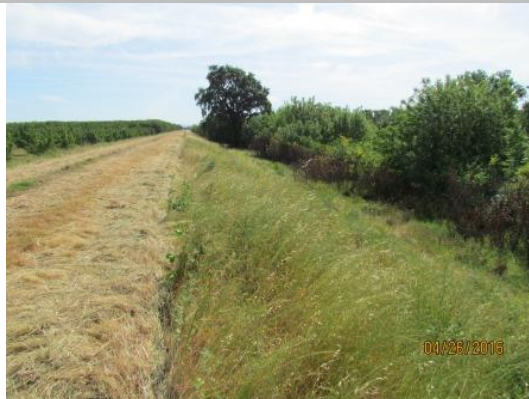
Photo 1 of 1 : SP_2016_RD0817_13_16_20160427_00017.jpg

LM Start	0.01	Rating **	M	Issue No.	16
LM End	3.83	Issue Type +	Ma	Location *	WS
Category	Earthen Levee			GPS Latitude/Longitude	
				Start	End
Item	Vegetation			38.984582 °	38.993173 °
				-121.506061 °	-121.437835 °
DWR ID	DWR_RD0817_02_s _ 2016_16				
Comment Code					
V1 : Control annual grass and weeds on the levee slopes and easements.					
Inspector Comment

View of typical vegetation on waterside slope looking upstream.

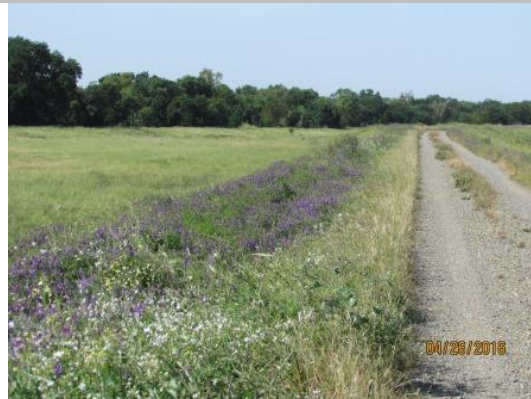
Photo 1 of 1 : SP_2016_RD0817_14_16_20160427_00025.jpg

LM Start	0.26	Rating **	M	Issue No.	16
LM End	1.27	Issue Type +	Ma	Location *	LS
Category	Earthen Levee			GPS Latitude/Longitude	
				Start	End
Item	Vegetation			38.987671 °	38.996877 °
				-121.506478 °	-121.491960 °
DWR ID	DWR_RD0817_03_s_2016_16				
Comment Code					
V1 : Control annual grass and weeds on the levee slopes and easements.					
Inspector Comment

View of typical vegetation on the landside looking upstream.

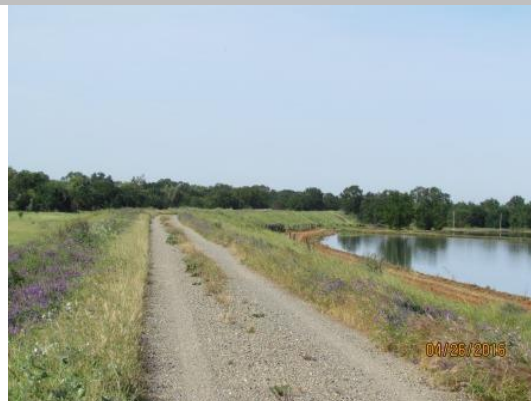
Photo 1 of 1 : SP_2016_RD0817_14_17_20160427_00026.jpg

LM Start	0.26	Rating **	M	Issue No.	17
LM End	1.27	Issue Type +	Ma	Location *	WS
Category	Earthen Levee			GPS Latitude/Longitude	
				Start	End
Item	Vegetation			38.987670 °	38.996877 °
				-121.506477 °	-121.491960 °
DWR ID	DWR_RD0817_03_s_2016_17				
Comment Code					
V1 : Control annual grass and weeds on the levee slopes and easements.					
Inspector Comment

View of typical vegetation on the waterside looking upstream.

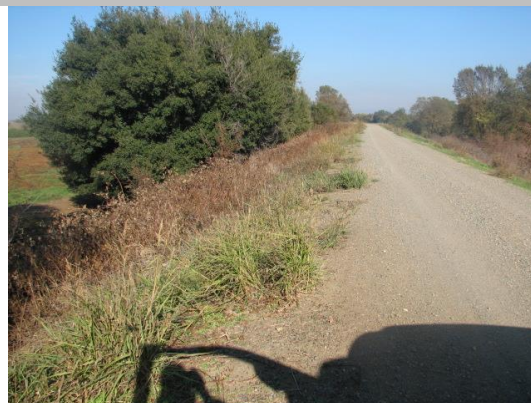
Photo 1 of 1 : SP_2016_RD0817_14_8_20160307_00001.jpg

LM Start	0.55	Rating **	U	Issue No.	8
LM End	0.81	Issue Type +	Ma	Location *	LS
Category	Earthen Levee			GPS Latitude/Longitude	
				Start	End
Item	Vegetation			38.989961 °	38.992220 °
				-121.502009 °	-121.498198 °
DWR ID	DWR_RD0784_06_f_2012_8				
Comment Code					
V2 : Remove the wild growth other than native grasses from the levee slopes.					
Inspector Comment					
Dense berry bushes along lower slope.

Levee mile 0.54, the landside slope.

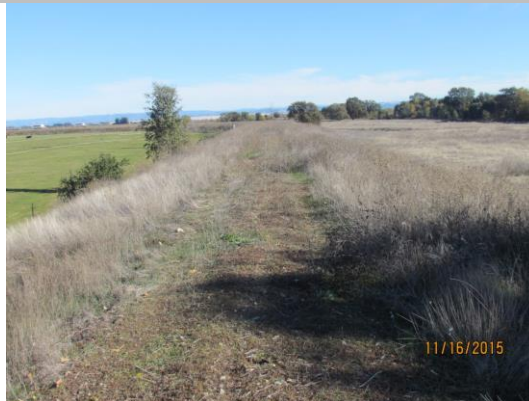
Photo 1 of 1 : SP_2016_RD0817_14_14_20160307_00002.jpg

LM Start	1.28	Rating **	M	Issue No.	12
LM End	1.50	Issue Type +	Ma	Location *	LS
Category	Earthen Levee			GPS Latitude/Longitude	
				Start	End
Item	Vegetation			38.997019 °	38.999719 °
				-121.491802 °	-121.490147 °
DWR ID	DWR_RD0784_06_f_2012_12				
Comment Code					
V2 : Remove the wild growth other than native grasses from the levee slopes.					
Inspector Comment					
Vegetation picture is the same as the picture on the crown.

LM Start	1.28	Rating **	M	Issue No.	14
LM End	1.50	Issue Type +	Ma	Location *	CR
Category	Earthen Levee			GPS Latitude/Longitude	
				Start	End
Item	Vegetation			38.997019 °	38.999719 °
				-121.491802 °	-121.490147 °
DWR ID	DWR_RD0784_06_f_2012_14				
Comment Code					
V2 : Remove the wild growth other than native grasses from the levee slopes.					
Inspector Comment					
This levee section needs an all weather surface added to the crown.

View of the vegetation on the crown of the levee looking upstream. Fall 2015.

LM Start	1.28	Rating **	M	Issue No.	13
LM End	1.50	Issue Type +	Ma	Location *	WS
Category	Earthen Levee			GPS Latitude/Longitude	
				Start	End
Item	Vegetation			38.997019 °	38.999719 °
				-121.491802 °	-121.490148 °
DWR ID	DWR_RD0784_06_f_2012_13				
Comment Code					
V2 : Remove the wild growth other than native grasses from the levee slopes.					
Inspector Comment					
Vegetation picture is the same as the picture on the crown.
